Experience and Risk assessment of FPSOs in use on the Norwegian Continental Shelf

Descriptions of Events

Roger L Leonhardsen, Gerhard Ersdal and Arne Kvitrud
Norwegian Petroleum Directorate
Stavanger, Norway

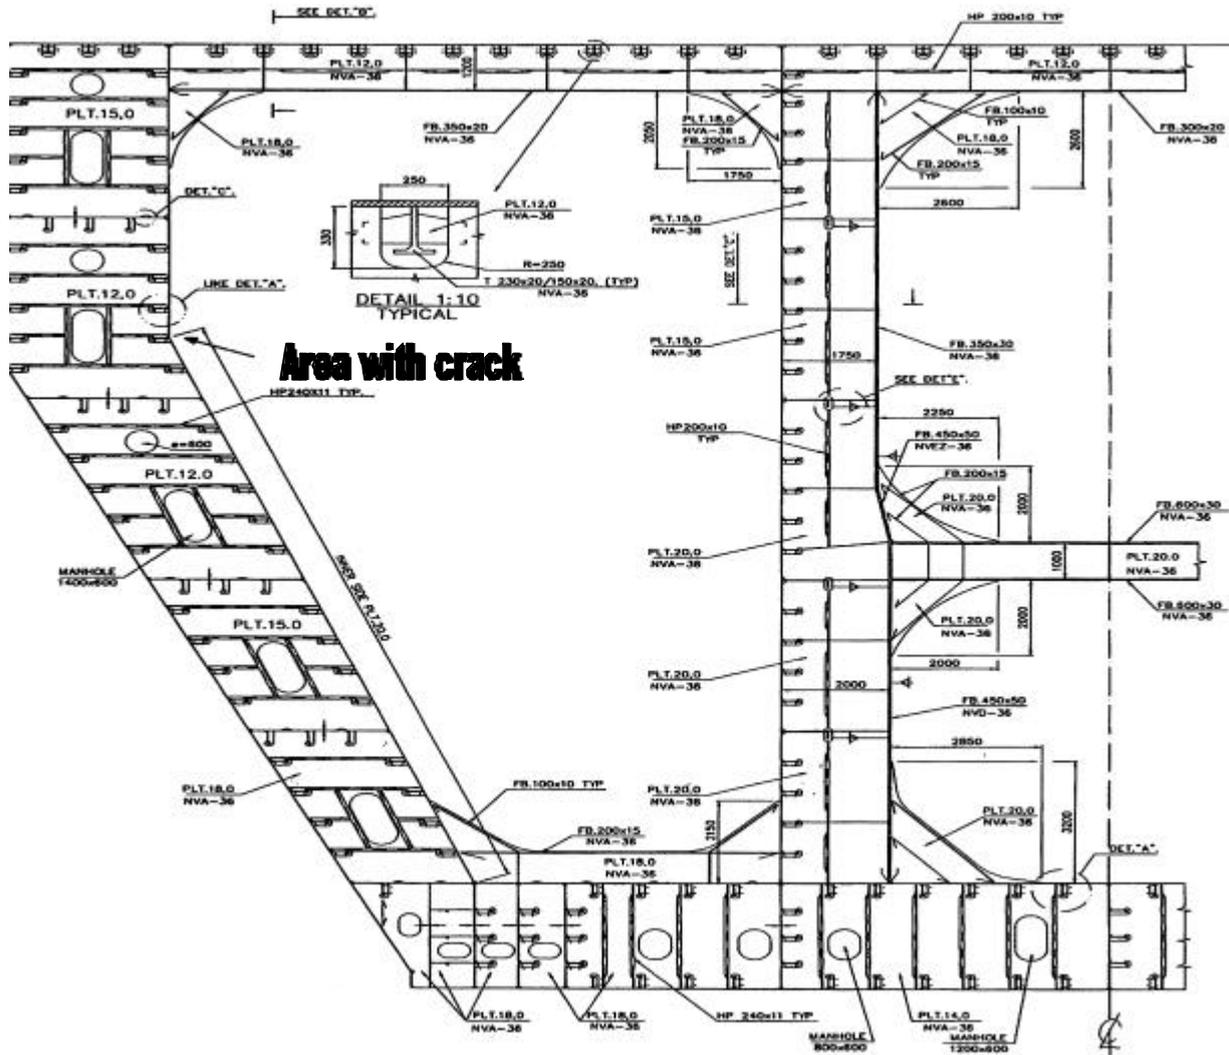
Cracking of welds between cargo- and ballast tanks have been experienced on Norne FPSO, and was first detected in March 1999. 6 of 10 cracks are through thickness and have caused oil seepage from the cargo tanks into ballast tanks (Statoil, 1999). Figure 3 (in the appendix) is an example of where a crack has occurred. The figure shows the transverse frame; see the intersection between the transverse frame and the knuckle line and longitudinal stiffener. The cause of these cracks is not properly settled yet. It is worth mentioning that all the cracks have been repaired continuously.

Figure 3: Example of cargo- and ballast tank where crack has occurred.
