Experience and Risk assessment of FPSOs in use on the Norwegian Continental Shelf

Descriptions of Events

Roger L Leonhardsen, Gerhard Ersdal and Arne Kvitrud
Norwegian Petroleum Directorate
Stavanger, Norway

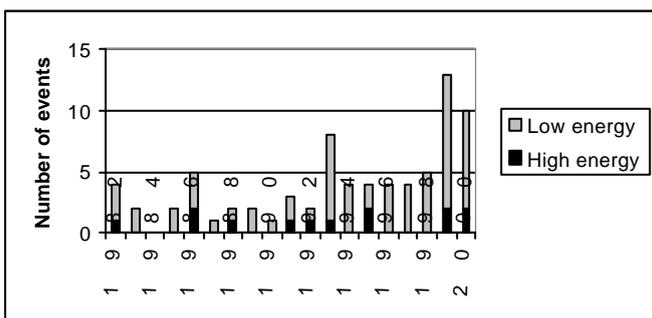
The “high energy” collisions seem to be fairly evenly distributed over time, but the number of collisions peak in 1993 and 1999 - 2000. The reason for this might be that NPD in these years made special efforts to collect data and thus highlighted the collision risk to the operators. There seems also to be an increase of events over time, but this might be caused by the improved reporting routines. An average number of ten collisions each year is not unrealistic for the 1990s. Most of them have a small potential to cause significant damage.

Figure 1: The number of collisions on the NCS 1982 - 2000 as reported to NPD. The collisions are classified as low- or high energy as described in the text.

In figure 1, most events are connected to vessels operating close to an installation. All but one of the “high energy” collisions with authorized vessels is connected to errors and mal operation of the DP system. One “high energy” collision occurred when the vessel lost power to thrusters.

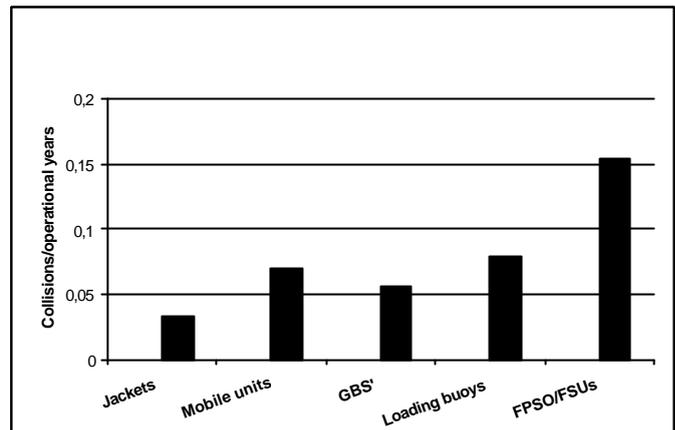
Historically NPD have recorded five incidents which directly can be linked to cargo offloading operations. Four of the incidents were between loading platforms and tankers. Figure 2 shows the estimated collision frequencies based on the reported number of collisions and operational years for the specific installation type.

Figure 2: Collision frequencies on the NCS 1982 – 2000.

The average collision frequency for jackets, mobile units, GBS' and loading buoys are in the order of 0.059, while the overall collision frequency for FPSO/FSUs are more than 2 1/2 times higher. If we compare collision frequencies involving offloading cargo from either a loading buoy or FPSO/FSU, our data seems to come out almost equal with 0.078 and 0.051, respectively. The collision frequencies for mobile units and loading buoys are 0.149, combined, and in line with the overall frequency estimated for FPSO/FSUs of 0.154. From this it may be concluded that the collision probability for FPSO/FSUs, loading buoys and mobile units are almost equal. When performing cargo offloading from FPSO/FSUs, the consequences of a possible impact is regarded as higher than for other installations due to the size of the visiting vessels. Our data also show that DP system errors (mal function/operation) account for the major part of all impacts for all kinds of visiting vessels. We have also received one report of drift off and one of drive off while positioning tankers for a loading operation. An increasing use of shuttle tankers operating close to the installations will therefore contribute to a higher risk.
